TACTICAL BRIDGE ACCESS//GRESS PRELIMINARY
INVESTIGATIONS(U) ARMY ENGINEER WATERWAYS EXPERIMENT
STATION VICKSBURG MS GEOTECHNICAL LAB B A MATIS SEP 80

*Tactical Bridge Access/Egress
Preliminary Investigation*

Case, Gordon L.; Green, Hugh L.; Taylor, Hugh M. Sept. '80

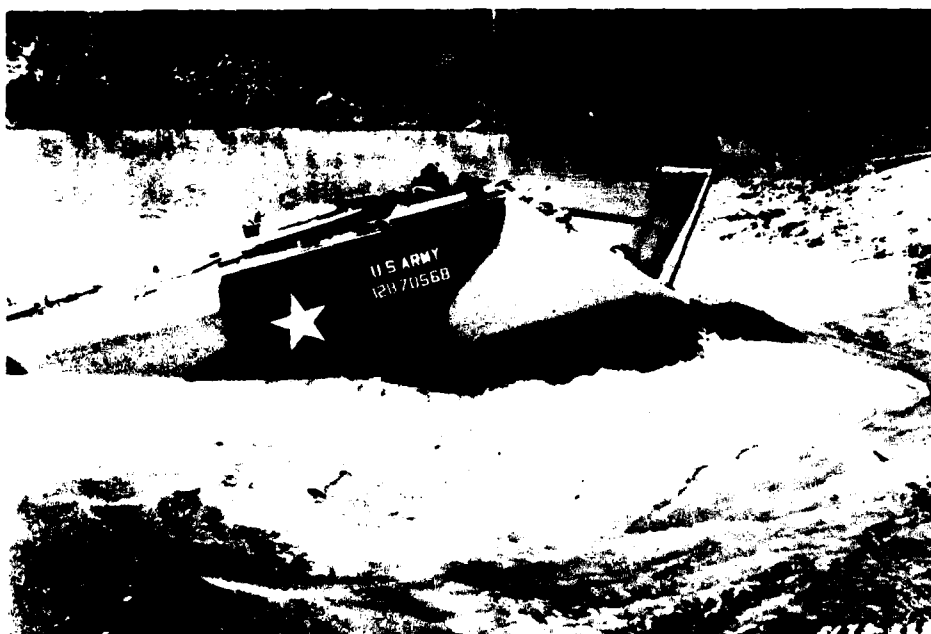
b. M113 APC encountering mat in lake near water's edge

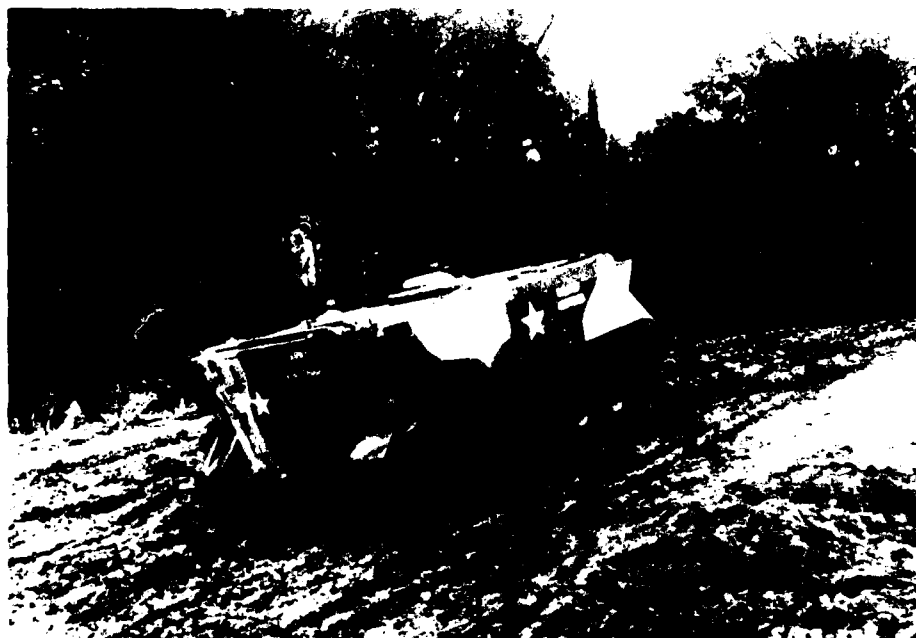
h. Vehicle climbing toward rest of wet slope
